# A 40-year fight against corrosion in kraft recovery boilers: A review

## Low alloy chromium-molybdenum steels have better resistance

BY S. INGEVALD, F. BRUNO  
AND F. EKQVIST

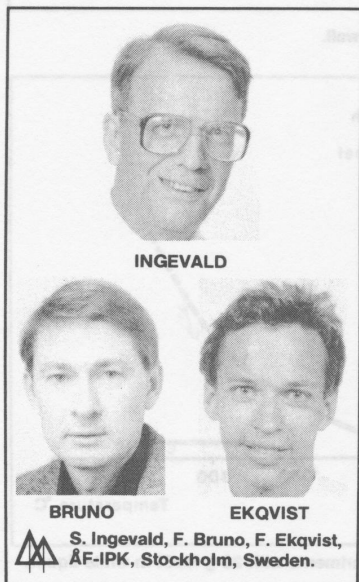
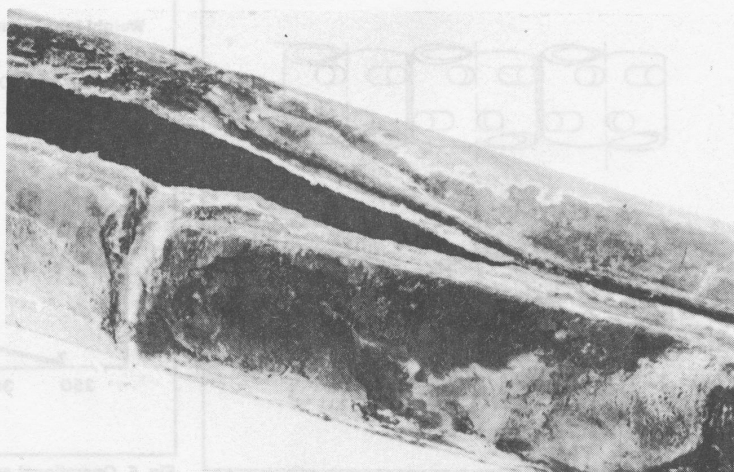
The first tube leak damage due to corrosion was reported in 1948. Later on, similar cases were observed during maintenance work on blocked walls. Figure 1 shows the typical appearance of such corrosion between the blocks. At that time, it was still argued whether the corrosion occurred during the weekend shutdowns by galvanic corrosion or if it was caused by the molten smelt.

Since heavy waterside deposits were observed in some cases, elevated tube temperatures were concluded to be a main cause. Corrosion tests showed that the corrosion from molten smelt is very intense, see Fig. 2. As boilers were built

Fig. 1. Corrosion between blocks.

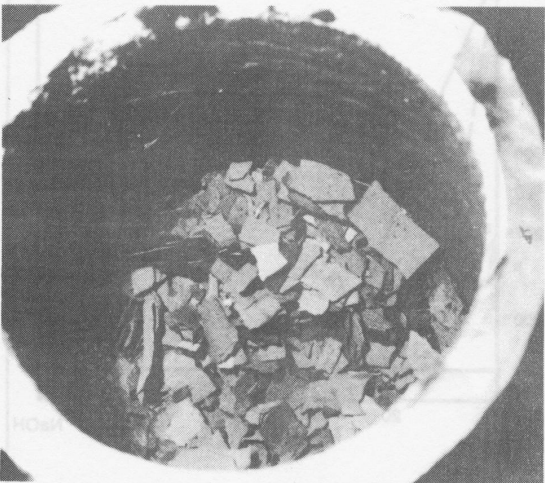
Fig. 8. Scaling of superheater tube.

One recovery boiler, however, suffered high temperature corrosion of the secondary superheater, caused by an unstable steam temperature control combined with a leak in one of the two steam attemperators. Due to the steam attemperator leak, boiler water entered the secondary superheater, where the boiler water constituents were left on the tube walls causing overtemperatures.

The high overtemperatures caused the tubes to form a thick oxide layer. This thick layer spalled off and caused blockage of the tube bends, so the tube wall temperatures approached the flue gas temperature [Fig. 8]. The tube burst that followed was caused by rapid creep and was not due to tube thickness reduction.

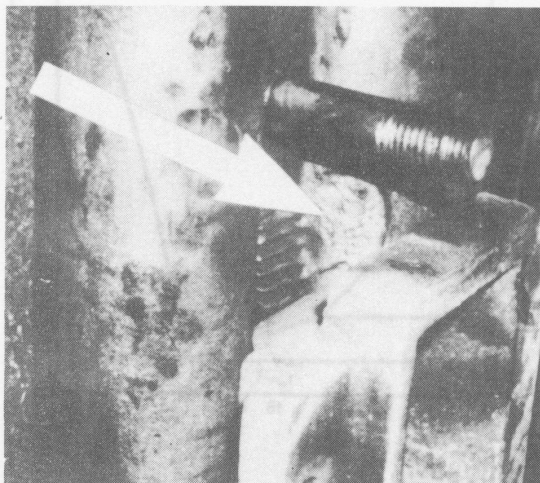
Fig. 9. Corrosion site at air inlet nozzle.

**Primary air register corrosion:** Some older Swedish recovery boilers, have suffered badly from corrosion in the primary air register areas (Fig. 9). The corrosion model is based on the condensation of hydroxide vapors, which form low-melting point deposits in hidden areas in the primary air register.

The vapors are formed while incinerating the liquor. The corrosive deposits contain mainly carbonates and hydroxides. The sulphur content of the deposits is usually low, indicating that the corrosion is not caused by kraft smelt per se.

As a consequence of the high hydroxide content of the deposits, they will have low eutectic points extending down to, and below, the boiler water temperature. Thus, units with a higher steam pressure are more vulnerable to this type of corrosion. The eutectic temperature of pure sodium hydroxide-sodium carbonate mixtures is not low enough to initiate corrosion at 6 MPa pressure, because the tube surface temperature then still is below the eutectic point (Fig. 10).

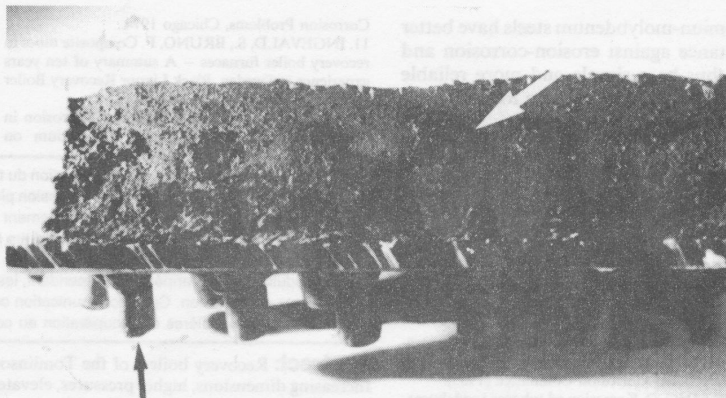
**In furnace tubes:** Localized corrosion in the waterside has been reported in two cases. In one case, the corrosion occurred opposite to the plates of the primary air ports. In the other case, the corrosion appeared opposite to the pin studs (Fig. 12). This type of corrosion is caused by a high local heat flux in combination with unsuitable water treatment. Deposits will form opposite areas with high heat flux, causing wick boiling and local enrichment of boiler water constituents [13].

Fig. 12. Corrosion opposite pin studs.

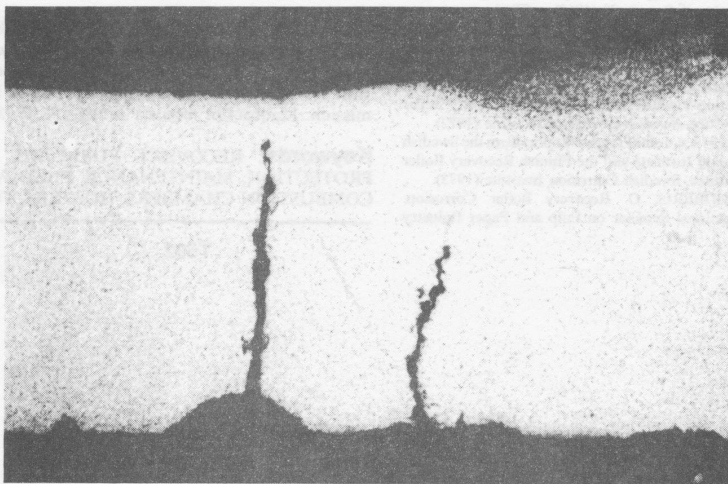
**In economizers:** Economizer cracking has been a recurring problem in several Swedish recovery boilers. The cracking occurs most often in the colder parts of tube economizers, often at the inlet header but also at the outlet header of the first and second economizer banks. The internal cracks occur circumferentially on the economizer tubes, often about 5 to 10 mm off the weld to the header (Fig. 13).

Fig. 13. Corrosion cracks near weld to header. Note corrosion pits.

Generally, newer economizers are longer than older ones, although the design has not changed otherwise. The tubes are then more free to absorb internal stresses. Any dissolved oxygen in the water contributes to cracking. Improved deaerating of the feed water has remedied most of this problem.

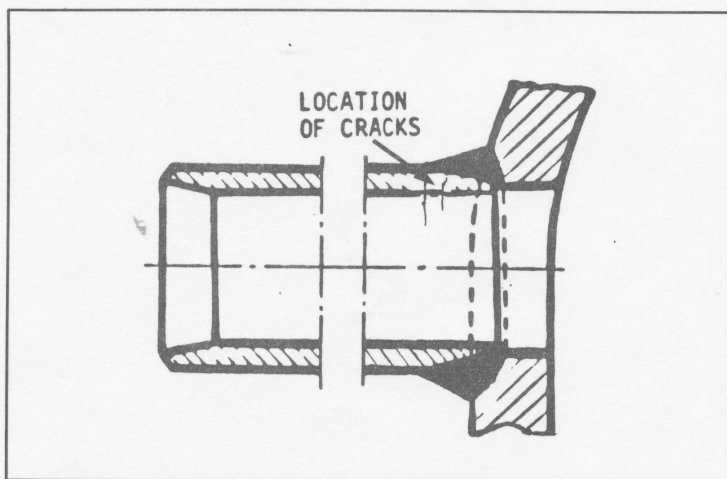
The bending stresses of the tubes are highest here because the tubes close to the header are supported by a rigid header and weld configuration (Fig. 14). Since the economizer is not steaming, it lacks the temperature stabilization of the boiling process which otherwise would keep the temperature of the tubes close to the water boiling point.

Fig. 14. Location of cracks.
