# A 40-year fight against corrosion in kraft recovery boilers: A review

## Low alloy chromium-molybdenum steels have better resistance

BY S. INGEVALD, F. BRUNO  
AND F. EKQVIST

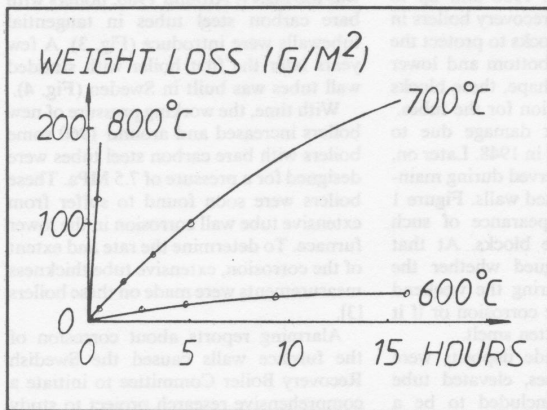
Since heavy waterside deposits were observed in some cases, elevated tube temperatures were concluded to be a main cause. Corrosion tests showed that the corrosion from molten smelt is very intense, see Fig. 2. As boilers were built

Fig. 2. Carbon steel corrosion by kraft smelt [2].

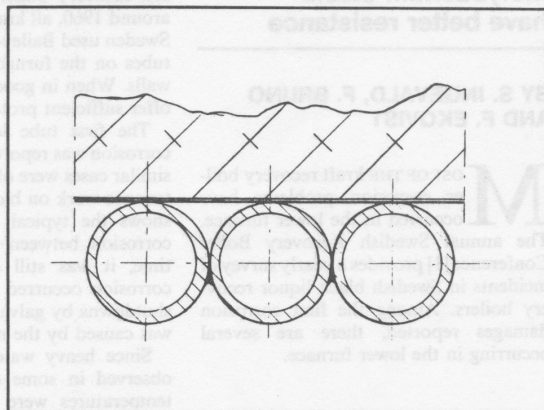
Fig. 3. Tangential tube wall.

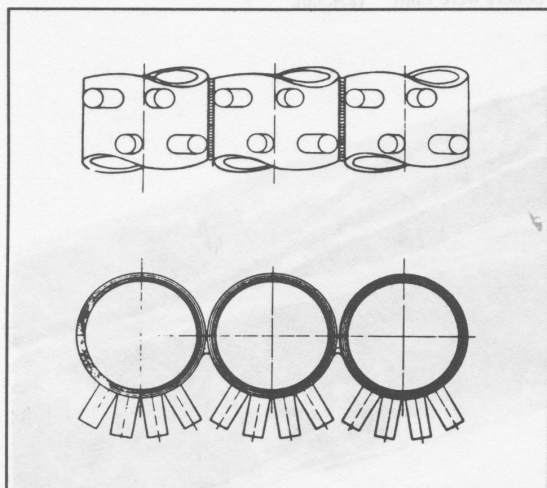
Fig. 4. Studded tube wall.

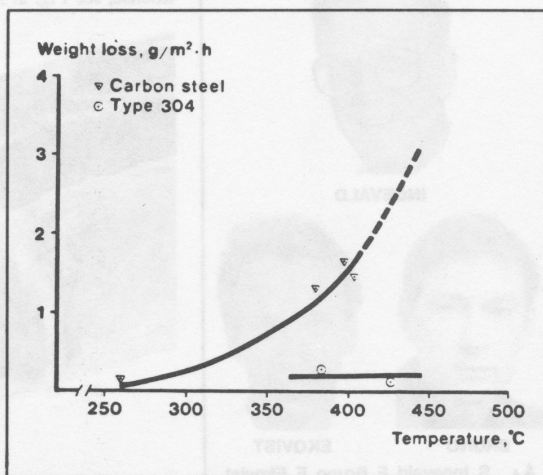
- The highest corrosion rate occurred at a  $O_2:H_2S$  ratio in the flue gas of about 1:1.
- The corrosion rate increased rapidly at temperatures above  $300^\circ C$  (Fig. 5).
- A frozen layer of kraft smelt as well as a magnetite oxide layer, reduced the corrosion rate considerably.
- Molten smelt is extremely corrosive when in direct contact with carbon steel.

Fig. 5. Operational experiments with 20 g NaCl in white liquor. Exposure 336 hours [2].

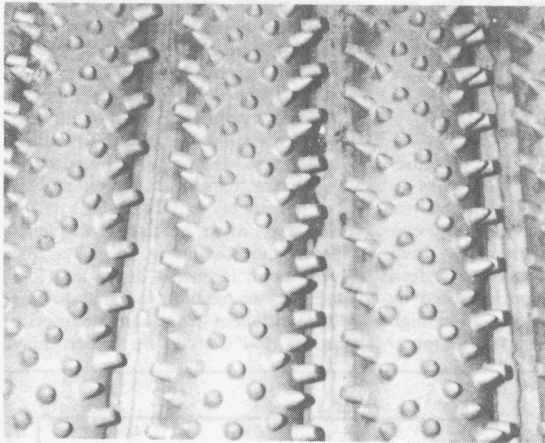
Fig. 6. Membrane wall with studded tubes.

**Protection by studs:** To get a good protection with studs (Fig. 6) they must secure a permanent frozen smelt layer on all tube parts. We recommend the following practices:

- An effective cleaning method must be used, leaving the surface free from smelt and oxides.
- Generally, the old studs have to be "top" ground to provide a good fusion. Lack of fusion causes excessive metal temperatures and shortens stud life considerably.
- A thoroughly-tested weld method should be used along with experienced welders.
- The restudding should be, at least, as closely spaced as the original.
- Stud materials alloyed with Al and as much as up to 25% Cr have shown good results when used in some boilers. (German Werkstoff No. 1.4742, X10CrA113 and 1.4762, X10CrA124.)

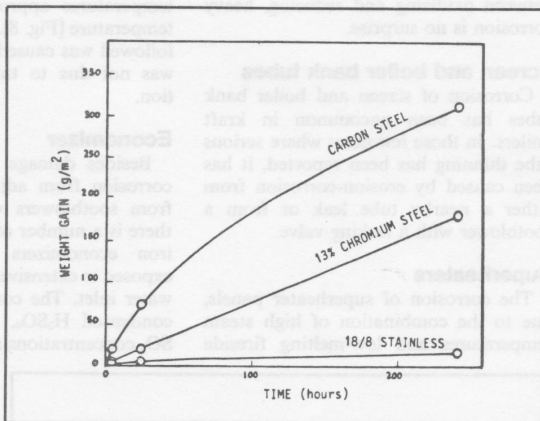
The results of these studies indicated that stainless steel with a chromium content above 116% had a corrosion rate 10 times lower than carbon steel when tested in the laboratory under the same simulated furnace conditions (Fig. 7).

Fig. 7. (0.1% H<sub>2</sub>S, 0.1% O<sub>2</sub>, 10% H<sub>2</sub>, 2% H<sub>2</sub>O, balance N<sub>2</sub>, 400°C) [7].

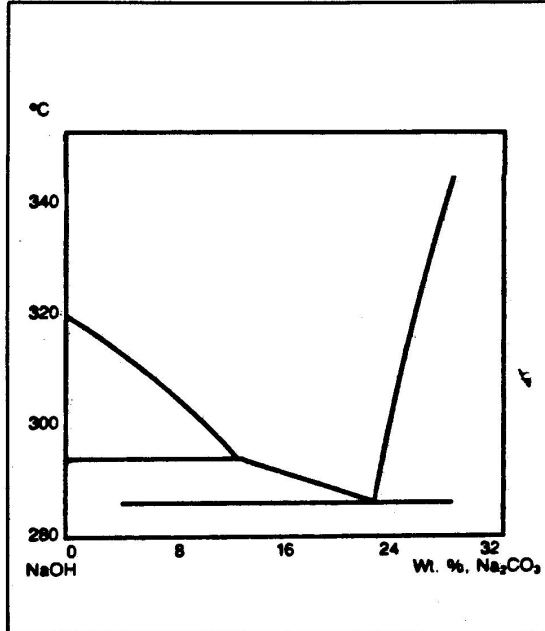
As a consequence of the high hydroxide content of the deposits, they will have low eutectic points extending down to, and below, the boiler water temperature. Thus, units with a higher steam pressure are more vulnerable to this type of corrosion. The eutectic temperature of pure sodium hydroxide-sodium carbonate mixtures is not low enough to initiate corrosion at 6 MPa pressure, because the tube surface temperature then still is below the eutectic point (Fig. 10).

Fig. 10. Phase diagram NaOH- $Na_2CO_3$  [12].

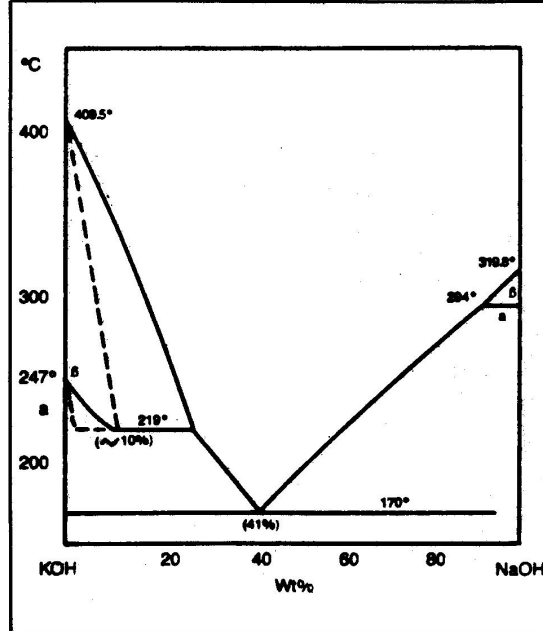
However, when potassium displaces some of the sodium in the salts, the eutectic point is further depressed (Fig. 11). Potassium/sodium ratios as low as 1:10 are sufficient to decrease the eutectic point to 250°C (480°F), which may

Fig. 11. Phase diagram KOH-NaOH [12].

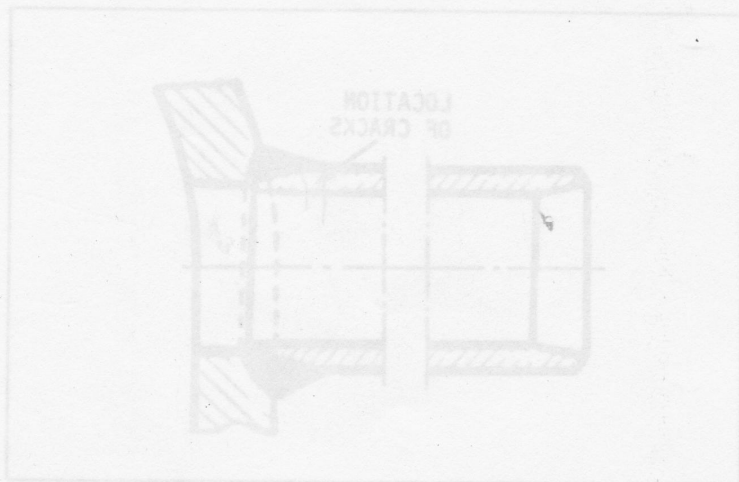
The bending stresses of the tubes are highest here because the tubes close to the header are supported by a rigid header and weld configuration (Fig. 14). Since the economizer is not steaming, it lacks the temperature stabilization of the boiling process which otherwise would keep the temperature of the tubes close to the water boiling point.

Fig. 14. Location of cracks.
